Improving RGA durability and endurance.

Dave Seymour
RGA10
October 2011

Hidden Analytical has manufactured Quadrupole Mass Spectrometers since 1982. Thousands of RGA's have been supplied to customers worldwide.

The detailed records of these units have been studied. The challenges to improve longevity and reliability are discussed.

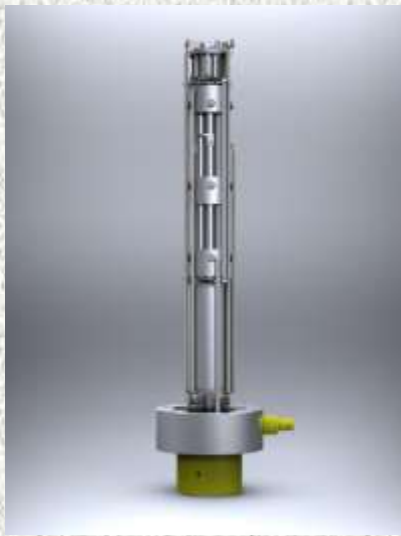
Broken feedthru

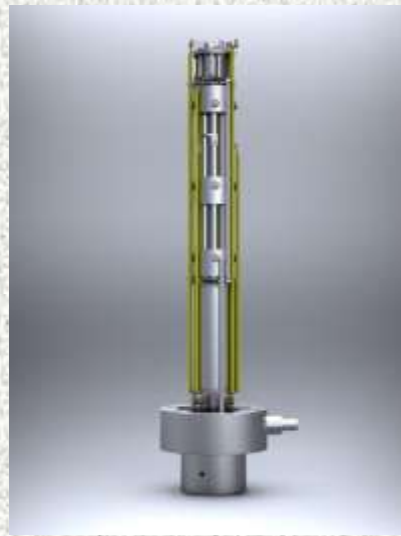
Wiring disconnect

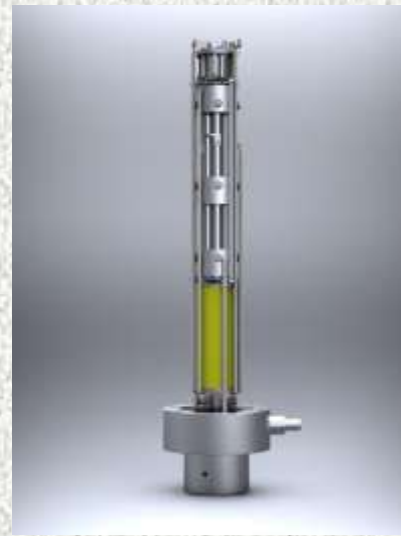
Detector end of life

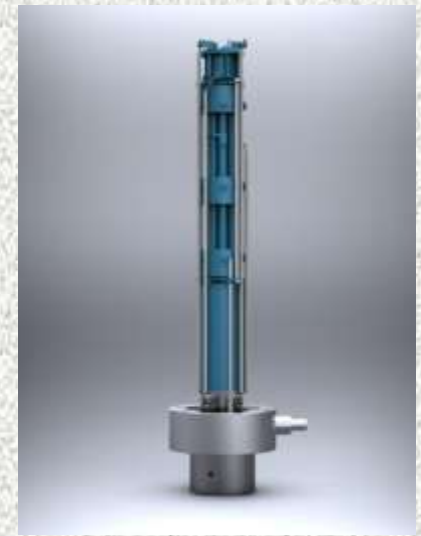
Contamination

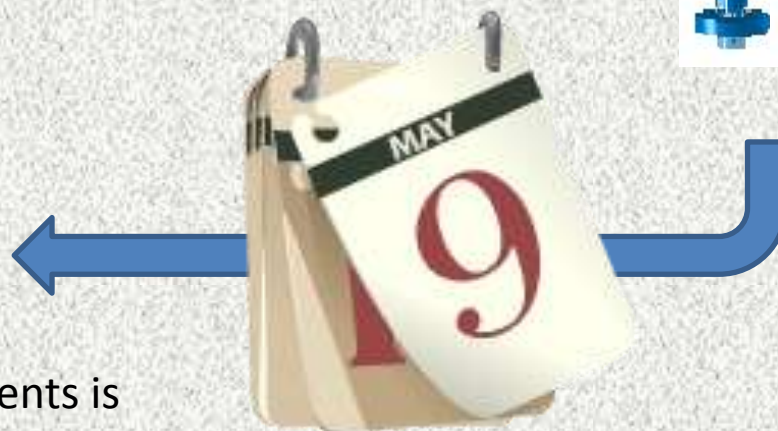
Average age of returning instruments is 6 years 7 months.

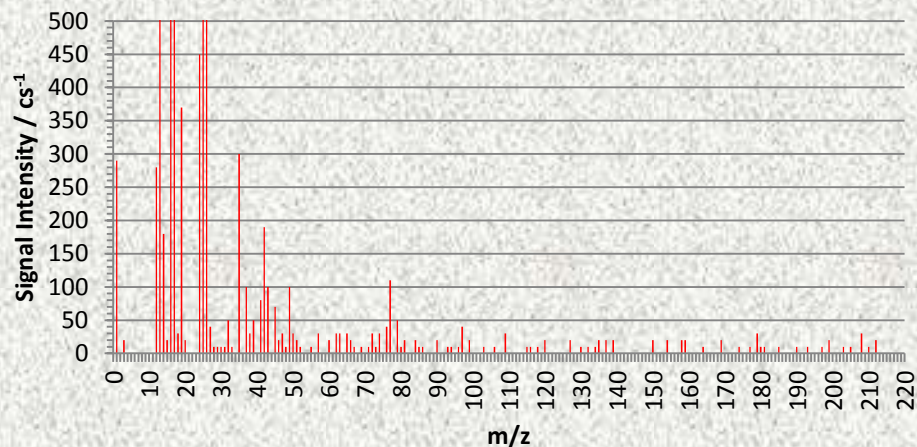
Negative Ion SIMS

Contaminated with silicon/silica
